FACILITY CONDITION ASSESSMENT VOLUME II: FACILITY CONDITION SUMMARY

ALAMO COMMUNITY COLLEGE DISTRICT

JULY 2005

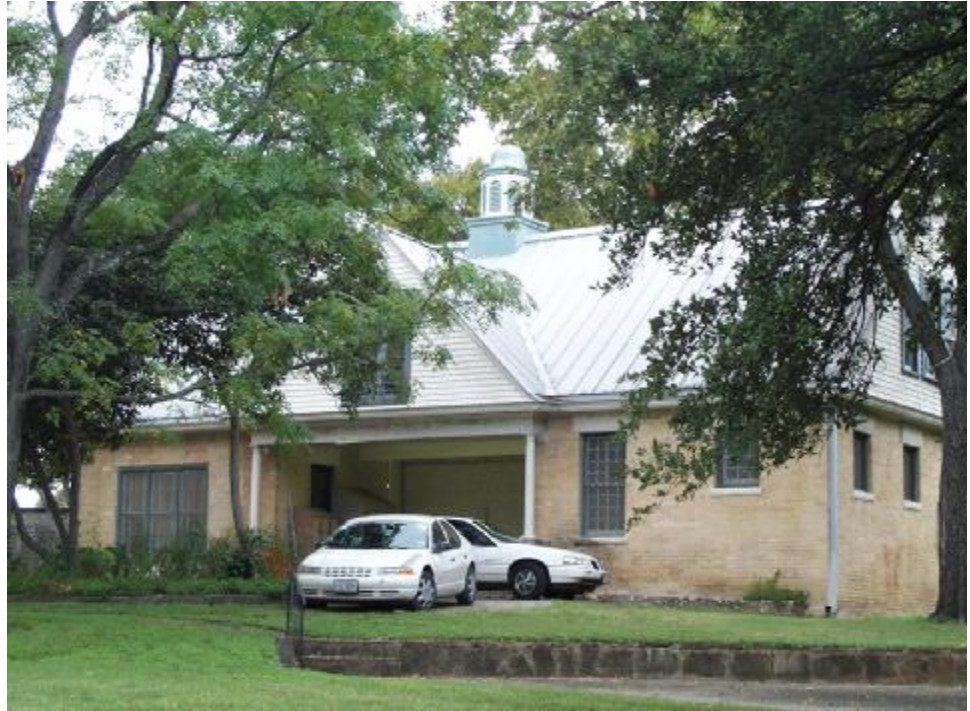
Bennet Carriage House (Custodial)

The Bennet Carriage House is located on the San Antonio Campus of the Alamo Community College District in San Antonio, Texas. The 2-story, 2,749 square foot building contains custodial offices and storage. Originally constructed in 1920, there have been no apparent additions or renovations.

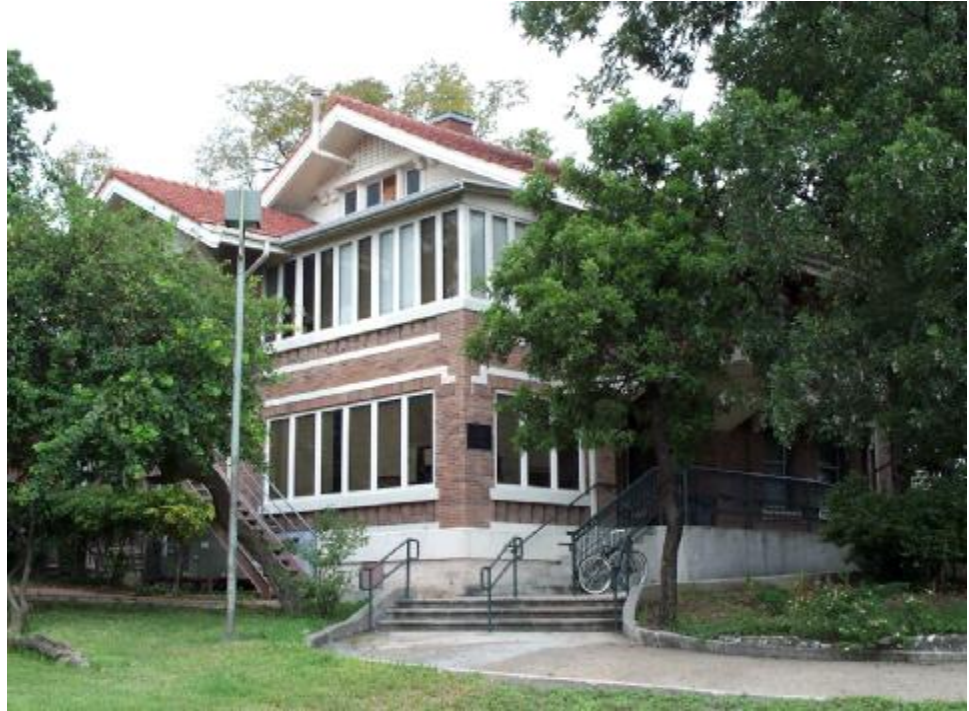
Bennet West (RTF Building)

West Bennet House (RTF Building) is located on the San Antonio Campus of the Alamo Community College District in San Antonio, Texas. The 2-story, 3,248 square foot building contains offices, classrooms, and audio rooms. Originally constructed in 1915, there have been no apparent additions or renovations.

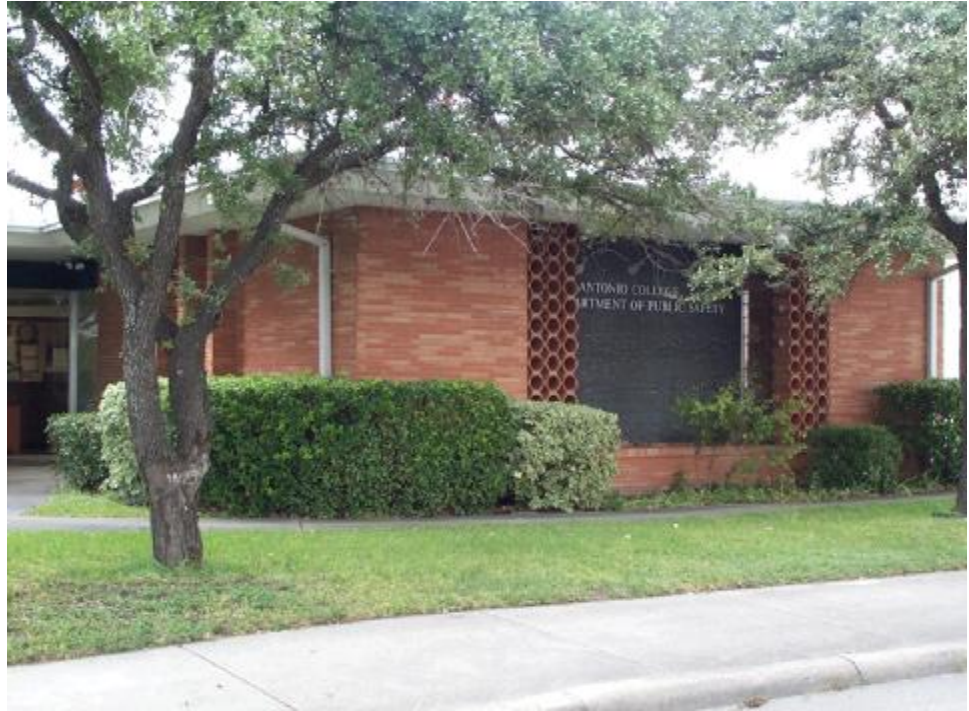
Architectural: This Campus Police Building, also known as the D.P.S. Building, is a one story brick faced structure constructed in 1973; there have been no major renovations. It has four places on the exterior of the building, several on the interior partitions, and one crack running across the full width of the building floor which evince building movement and/or vehicular damage. Also, behind the drink machine in the Reception/Lobby, there is wall damage (apparently overlooked when the repairs were made to the exterior of the Capt's Office, from the time a vehicle was driven into the building). In addition, there is evidence of previous termite infestation of the interior partitions and ceiling where paint easily delaminates from the substrate. There is also evidence of water damage in the building. While several areas of this building have been dressed up to improve their appearance, the College should consider replacing this building.

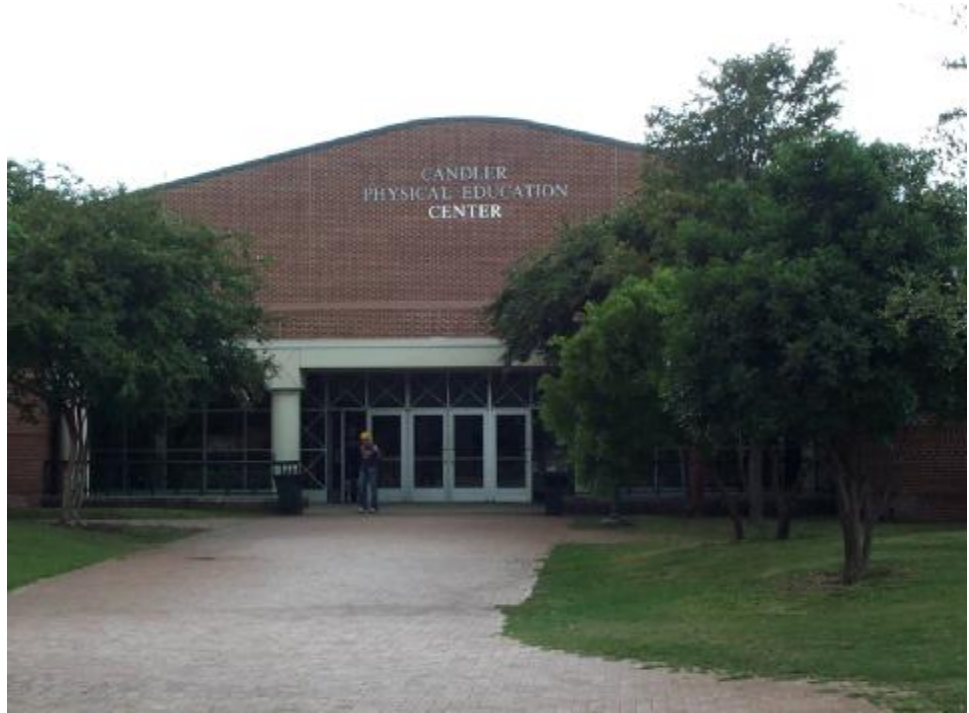
Architectural: The Chandler Physical Education Center consists of a building first occupied in 1951, and addition in 1986, and an addition and renovation in 1992. The three buildings comprise approximately 77,300 s.f. of concrete and steel frame construction with masonry infill. The facility houses two gymnasiums with one pair of locker rooms, a natatorium with its locker rooms, 10 racquet ball courts, weight and dance instruction rooms, classrooms and offices. The facility is in good shape except for some roofing issues leading to relatively small amounts of interior and exterior degradation, the normal corrosion occurring in the swimming pool area, and a ventilation issue leading to delamination of paint from about 900 s.f. of sheet metal at the ceiling in the east end of the old gymnasium.

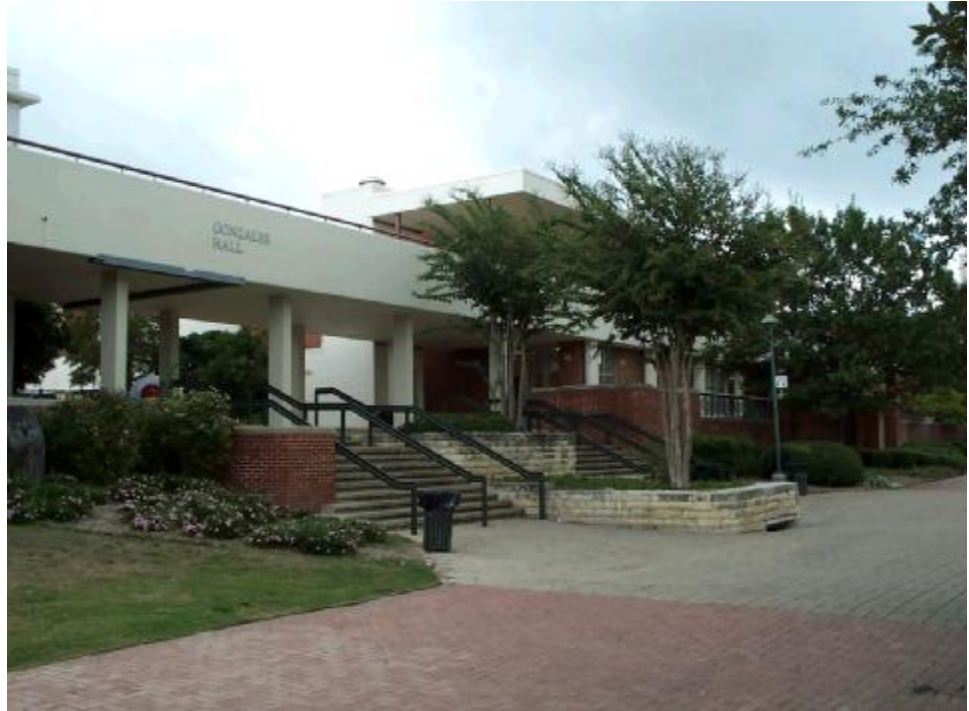
Architectural: Gonzales Hall is a two-story 31,588 square foot two story concrete frame, masonry construction building used primarily for computer instruction. The building was built in 1950, first occupied by the College in 1992 and received a renovation in 2003; the building is in generally good condition. Problems consist of needing new roofing, some cosmetic improvements, a few safety items, and replacement of some interior finishes.

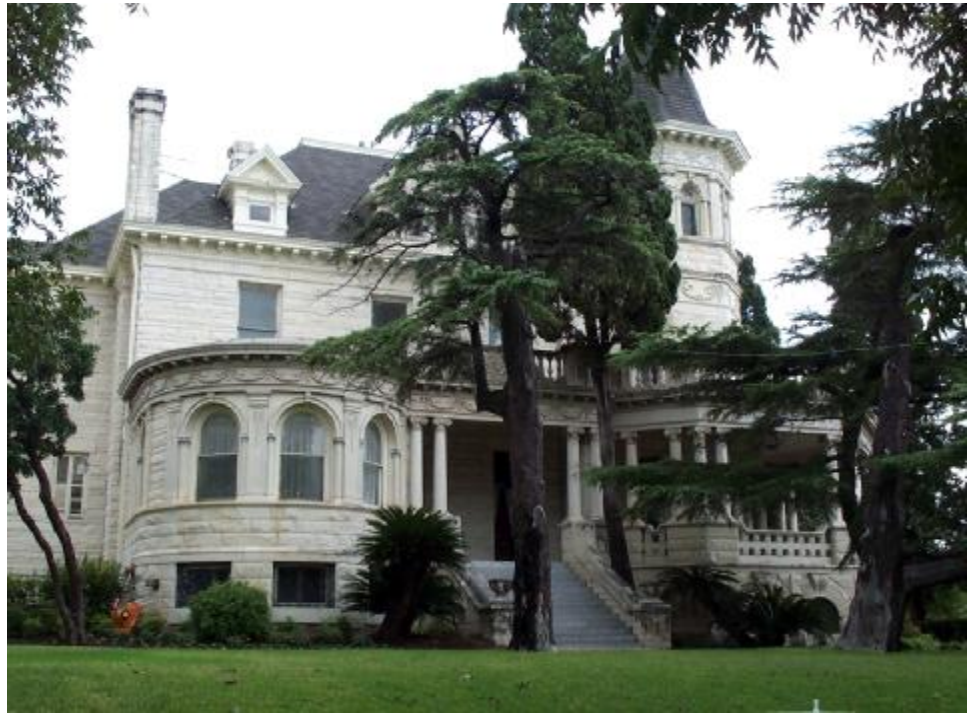
Architectural: The Koehler Cultural Center is carried in the THECB database as a 3-story, 12,655 s.f. house first occupied by the University in 1973. The house was constructed in 1901 for the president of Pearl Brewery, and is historic in nature. A glorious facility in its youth and well-maintained in many respects today, this house is suffering some serious problems on the exterior in the form of structural movement apparently due to differential settlement; there is some evidence of differential settlement in the basement as well. Several of the second story patios have members strapped in place. Other exterior flaws include degradation or separation of frieze and some stonework, delamination of column plaster, and deterioration of the wood window frames. Additionally, the property boundary fence, a combination of concrete base and custom made heavy wrought iron ornamental fencing, has given way to soils pressures and is atilt.

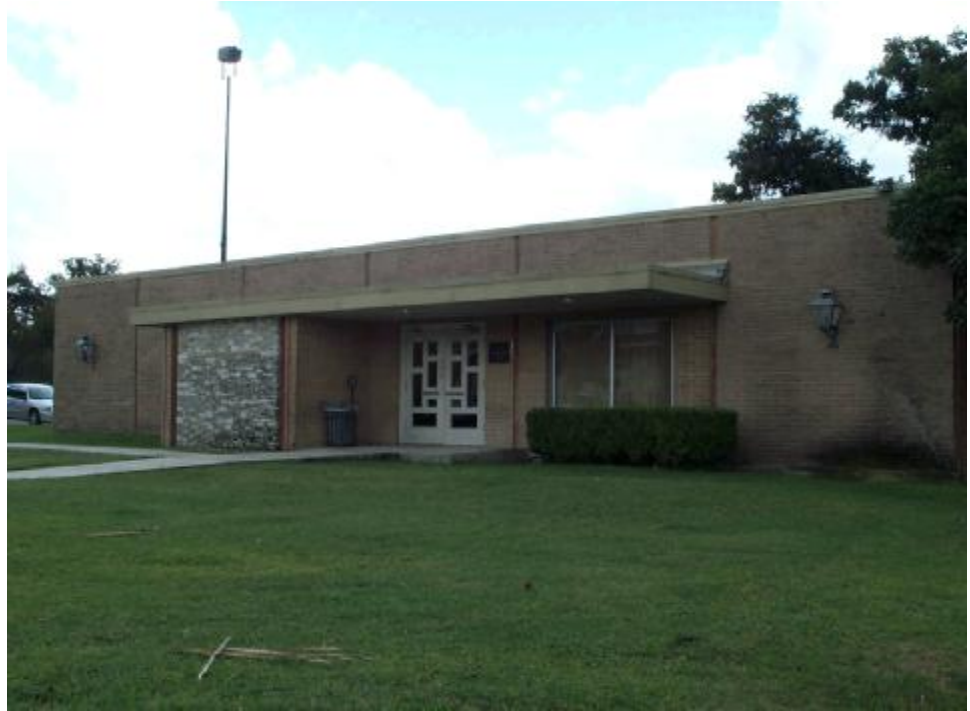
Law Enforcement Training Annex

Architectural: The 3,360 s.f. Law Enforcement Annex, built in 1964, is a steel framed building with brick exterior and combustible interior partitions. It houses law enforcement police training. A former religious facility, the building has suffered numerous stress cracks due to apparent differential settlement. Despite some renovation in 2001, the building has roof leaks and requires some refurbishment and new entrance doors.

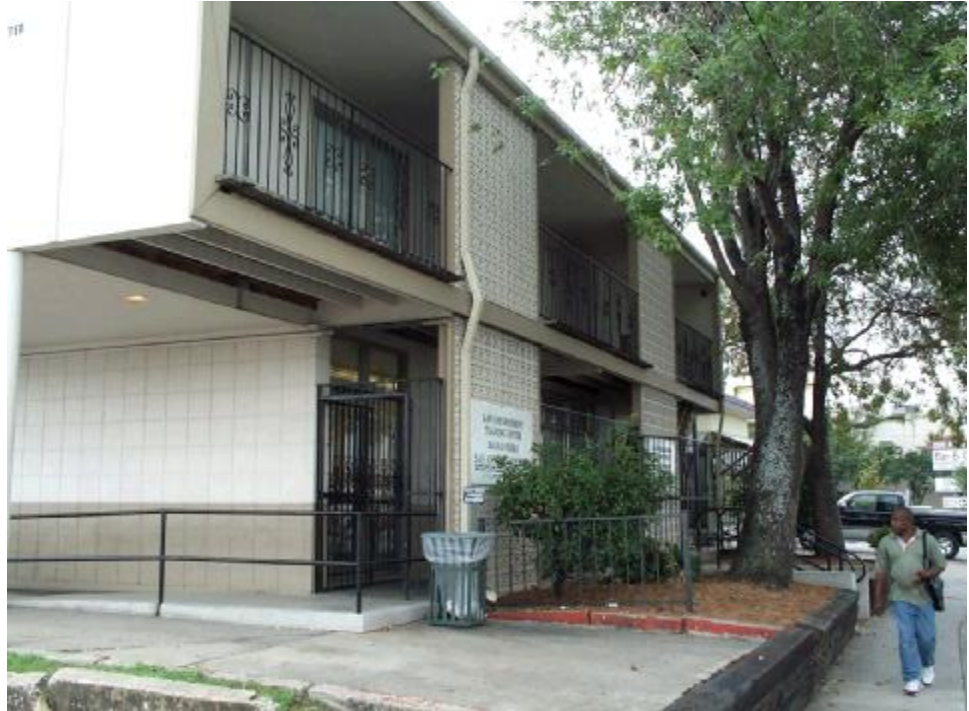
Architecture: The 4,645 s.f. Law Enforcement Training Center is a 1 and 2-story steel frame structure with mixed exterior construction and interior partitions of combustible construction that was constructed in 1973. The building houses law enforcement training. According to the occupants, the roof was replaced three years ago (2001), but several areas showed water damage and the occupants indicated leaks continue. Partitions, finishes, and the environment are not conducive to a top notch training environment. Additionally, organic growth was visible in the upstairs wall between the hallway and classroom 201.

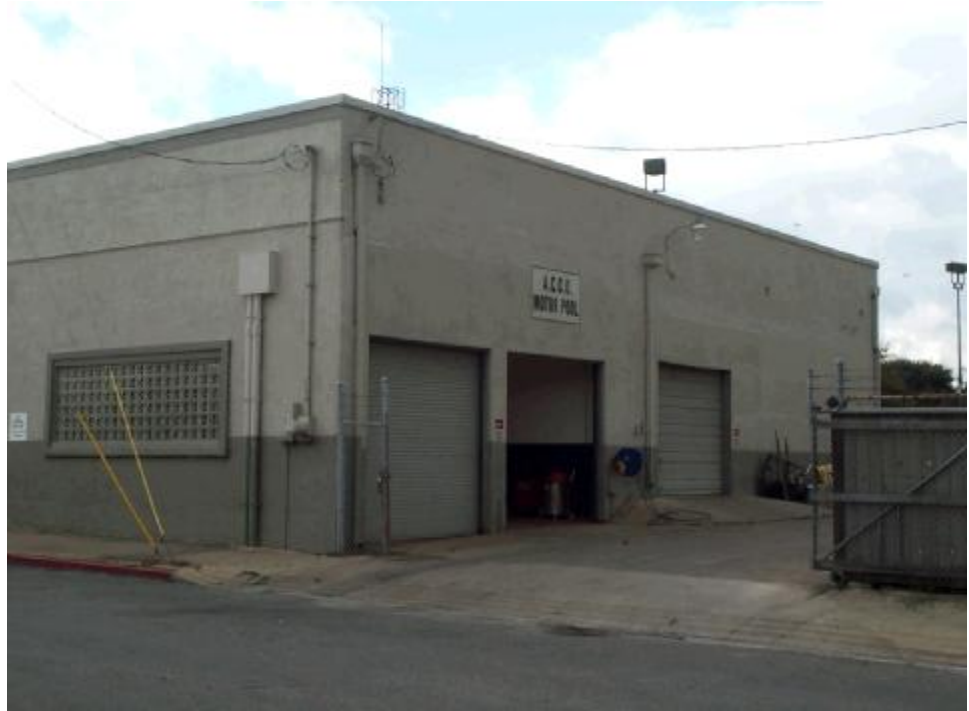
Architectural: The Motor Pool building is located on the campus of San Antonio College of the Alamo Community College District in San Antonio, Texas. The single story, 3,390 square foot building contains a several mechanical operations areas as well as offices. Originally constructed in 1938, there was an extensive renovation in 2000. The renovation included interior partition configuration, new flooring, and new lighting.

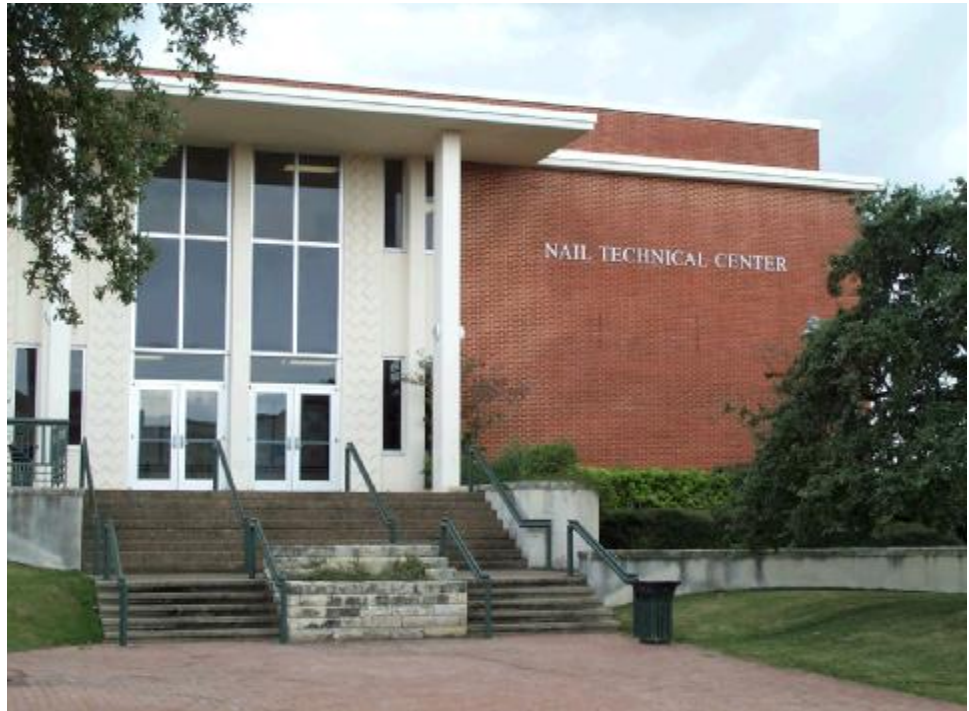
Architectural: The Nail Technical Center is a 3-story concrete frame, masonry-construction building completed in 1966. The terrazzo floors and ceramic tile walls in the main corridors are in excellent condition and should provide for minimum maintenance for years to come. The roof appears in good shape except for a few areas of slight sponginess and the need for replenishment of the sealant in the pitch pans. Having undergone a renovation in 2001, the building appears in overall good shape except for the need for minor amounts of painting and carpet replacement, some of which is already in process.

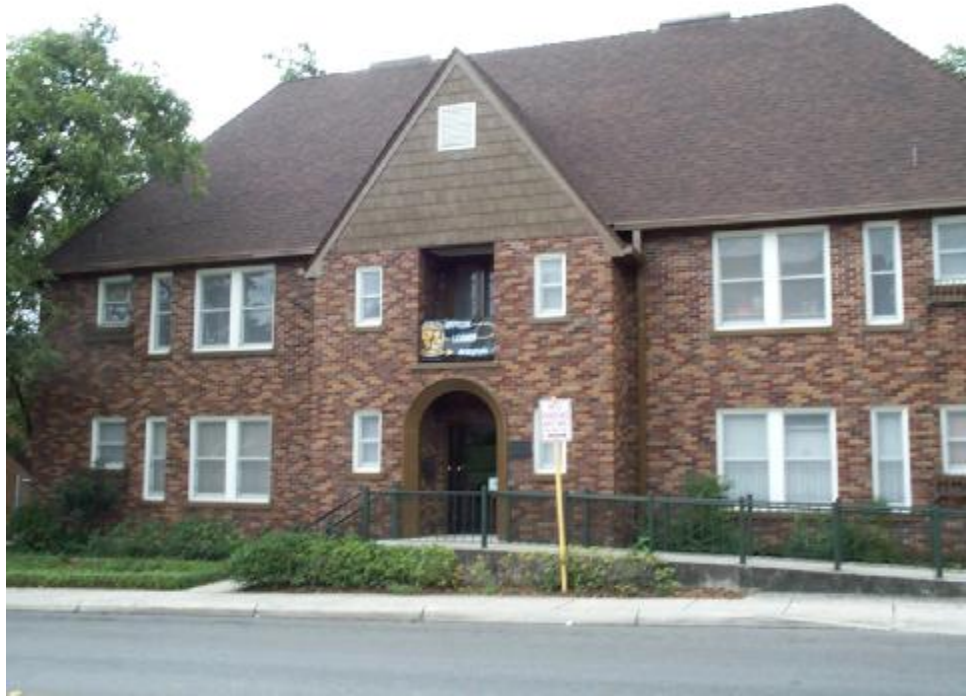
Sponsored Programs (JTPA)

Architectural: The JTPA Offices, also known as the Special Programs Offices is a former 4-plex residence of wood frame construction, brick exterior, and asphalt shingle roof. It houses the Special Programs offices and functions achieved through grants. Occupants indicated there are plans in place to replace the carpet throughout. One of the rooms contained computers to be put in place for one of the grant programs. Most of the listed architectural deficiencies will be remedied if the carpet is replaced. The roofing was recently replaced.
