FACILITY CONDITION ASSESSMENT VOLUME II: FACILITY CONDITION SUMMARY

ALAMO COMMUNITY COLLEGE DISTRICT

JULY 2005

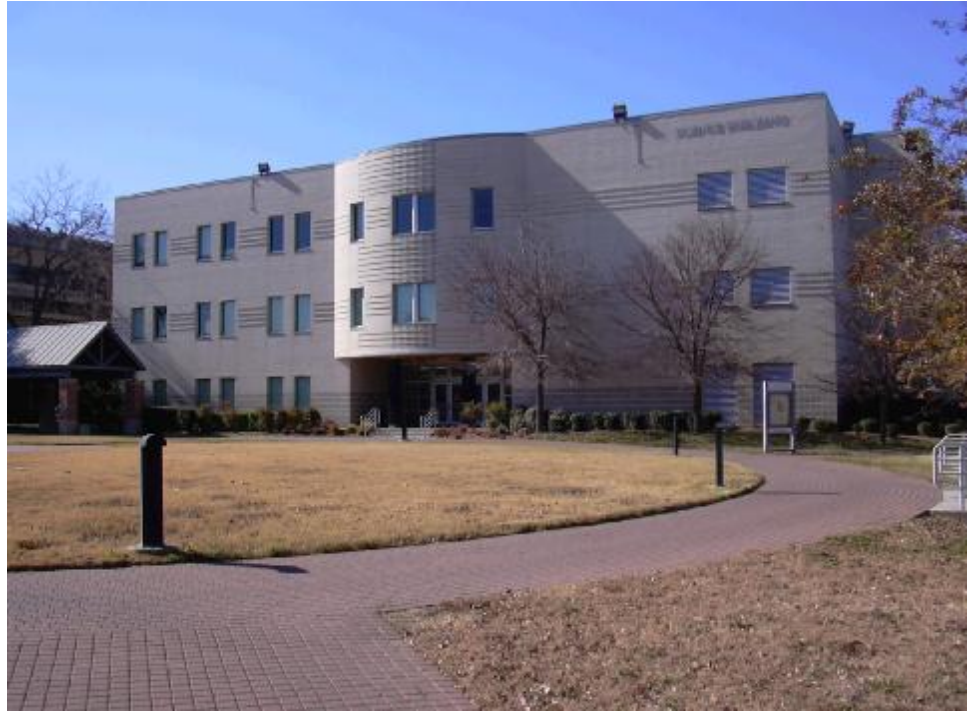
The Science Building is located on the St. Philip's Campus of the Alamo Community College District in San Antonio, Texas. The 3-story, 83,829 square foot building contains offices, labs, and classrooms. Originally constructed in 1992, there have been no apparent additions or renovations.

Site: Concrete sidewalks are in good condition and pose no hazard. Landscaped areas include trees, grass, and shrubs which are irrigated. Site drainage is generally adequate.

Structural/Exterior Closure: The building rests on piers and foundation walls that are not showing signs of settlement or damage. The main structure is steel frame with block infill and brick veneer. The roof is flat and is not leaking. Exterior doors are typically aluminum. Windows are typically aluminum frame, single-pane units.

Interiors: Partition walls are typically painted drywall. The interior wall finishes are generally in fair condition. Ceilings are 2X4 suspended acoustical tile that are generally in fair condition on the first and third floors, however the acoustical tile on the second floor is in poor condition. Flooring in high traffic areas is terrazzo. Most other flooring is vinyl tile or carpet. Interior doors are generally solid wood.

Mechanical/Plumbing: Heating is provided by steam from the central plant. Cooling is supplied by chilled water from the central plant. The heating/cooling distribution system is a 4-pipe system using air handlers, fan coil units and unit ventilators. Exhaust and supply fans have been added to the system to improve ventilation and air flow. Fresh air is supplied by air handling units and appears inadequate. Ceiling mounted exhaust fans are installed in bathrooms and ventilation is inadequate. Plumbing fixtures are original and are generally in good condition. Domestic water piping is copper and sanitary and roof drain piping is cast iron and is original. Domestic hot water is supplied by a 270,000 BTU gas-fired water heater. Chemical lab piping is not protected by an acid neutralization system. Controls are DDC and pneumatic and need to be upgraded.

Electrical: The electrical system is fed from a pad mounted transformer that delivers 277/480 volt, 3-phase, 4-wire power. The electrical distribution system is original. Lighting is typically recessed mounted fluorescent, 2x4 straight and 2x2 u-tubes, that do not fit the fixtures properly. Ballasts and lamps have been upgraded, but fixtures are original and should be replaced. Illumination is generally adequate. Emergency lights are not present. Exit signs are present at exit doors and near stairways and are typically illuminated. The building has a 150kW emergency generator. The building lacks security cameras.

Conveying: The building has a 2500# hydraulic elevator in good condition.

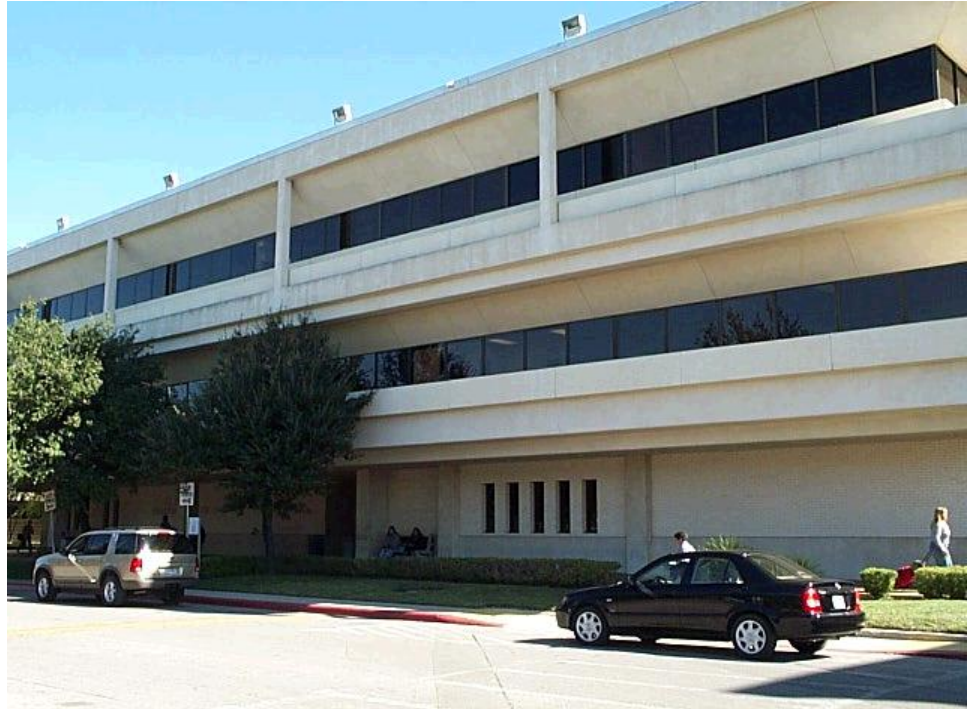
Architectural: The Sutton Learning Center is located on the campus of St. Philips College of the Alamo Community College District in San Antonio, Texas. The 3 story, 119,740 square foot building contains offices, classrooms, library, as well as other administration functions. Originally constructed in 1975, there have been several renovations. The renovations have been sporadic and only specific to departments and administration groups.

Site: Concrete sidewalks are in good condition and pose no hazard. Landscaped areas include trees, grass, shrubs, etc and are irrigated. Site drainage is generally adequate.

Structural/Exterior Closure: The building typically rests on footings and foundation walls that are not showing signs of settlement or damage. The main structures is typically concrete with some steel. A portion of the first floor has a brick veneer. The roof is a modified bitumen with a full parapet, no aggregate. The flashing around the skylight and the parapet wall is in good condition. No signs of ponding or bubbles were found. Exterior doors are typically store front glass. Windows are typically aluminum frame, single pane units.

Interiors: Partition wall types include painted drywall. The interior wall finishes are generally in good condition. Most ceilings are 2x4 suspended acoustical tile that are in fair condition. Flooring in high use areas is terrazzo on the first floor, vinyl tile on the second and third floor. Most of which is in fair condition. However, the terrazzo on the first floor has a few superficial cracks. Most other flooring is either carpet or vinyl tile, which is in fair condition. Interior doors are generally solid core wood in the corridors as well as in other interior spaces.

Mechanical/Plumbing: Heating and cooling for this building is provided by a 4-pipe chilled and heating water system. Heating is provided from a steam to water heat exchanger. Steam and chilled water are provided from the Central Plant. The air-handling equipment is original to the building. This equipment is beginning to deteriorate and should be scheduled for replacement. Restroom ventilation appears to be adequate. Ductwork in the building is largely original and should be scheduled for replacement. The restrooms were renovated in 1996 and water closets were replaced in 2004. Although the restrooms were renovated in 1996, some fixtures have been damaged or were improperly installed. Several areas throughout the building have an air distribution imbalance.

Electrical: The electrical system is fed from a 750 kVA pad mounted transformer that delivers 277/480 volt, 3-phase, 4-wire power to the building. The electrical distribution system is mostly original and needs to be upgraded. Lighting is typically recessed fluorescent and has been upgraded with electronic ballasts and T-8 bulbs. The fixtures are original, lenses are well worn and the hard connected wiring does not meet current standards. Illumination is generally adequate.

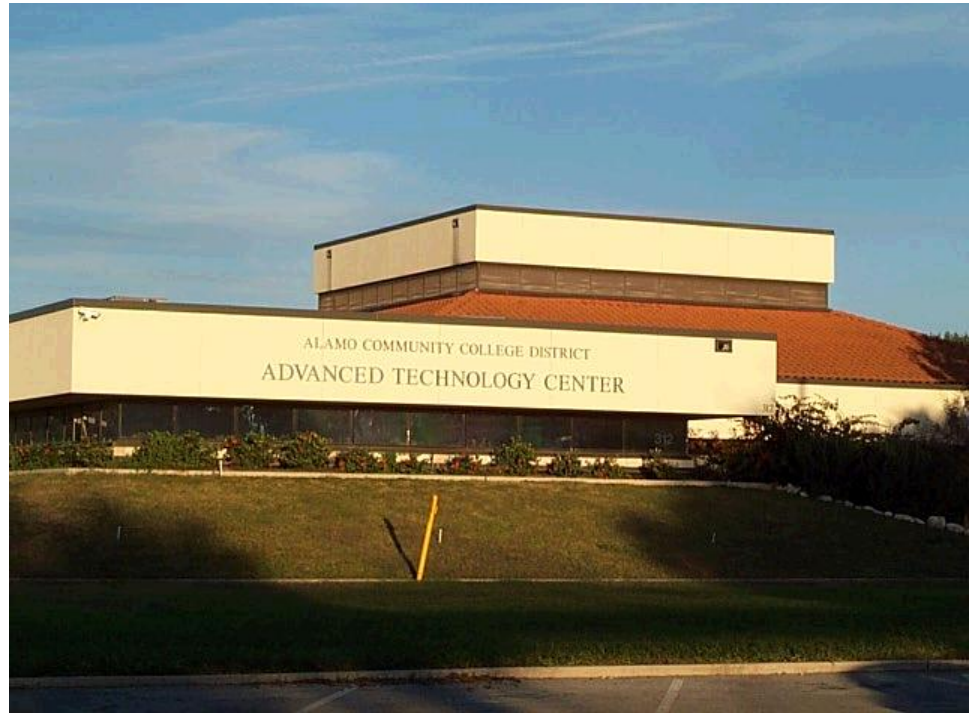
Photo Description:Advanced Technology Center at
Kelly AFB

Building 210 of St. Philip's College Southwest Campus is located on Kelly, USA and is part of the Alamo Community College District in San Antonio, Texas. The 1-story, 22,850 square foot building contains offices and classrooms. Originally constructed in 1982, there have been no additions or renovations.

Site: Concrete sidewalks are in good condition and pose no hazard. Landscaped areas include trees, grass, and shrubs and are irrigated. Site drainage is generally adequate.

Structural/Exterior Closure: The buildings typically rests on slab-on-grade with footings that are not showing signs of settlement or damage. The main structures is typically stucco over metal studs. The roofs are a combination of flat and sloped with ballasted built-up and clay tile and they are leaking. Exterior doors are typically aluminum and windows are typically aluminum frame, single-pane units

Interiors: Partition wall types include painted drywall and masonry. The interior wall finishes are generally in good condition. Most ceilings are 2x4 suspended acoustical tile that are in good condition. Flooring in high use areas is carpet. Most other flooring is ceramic and vinyl tile. Interior doors are generally solid wood in the corridors and solid wood in the administration and classroom areas.

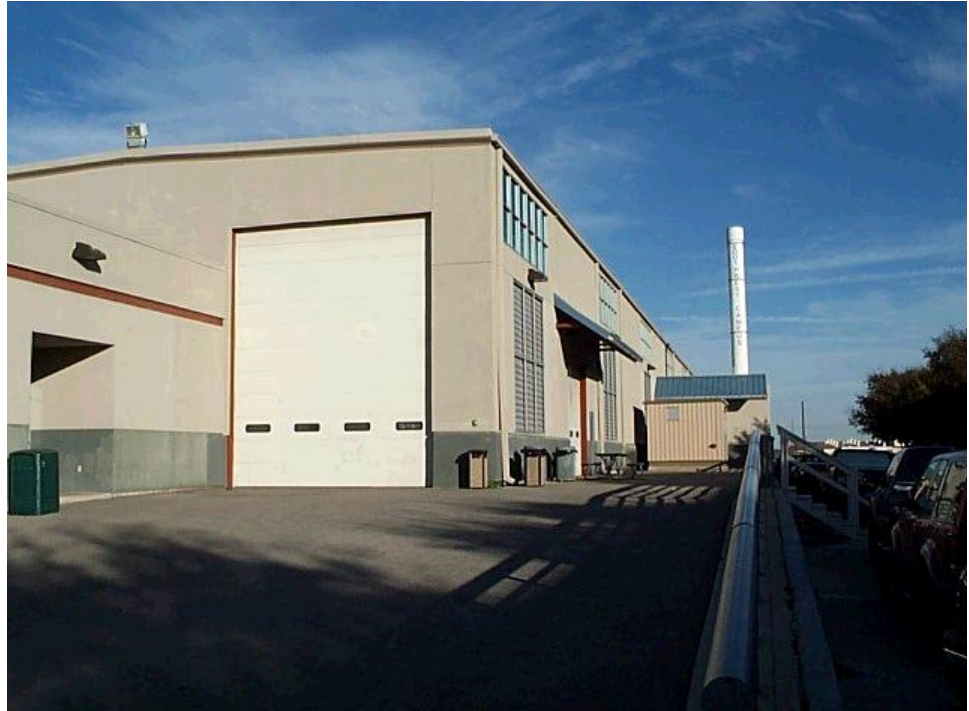
Building 3008 is located on St. Philip's College's Southwest Campus of the Alamo Community College District in San Antonio, Texas. The 1-story, 34,240 square foot building contains offices, classrooms, and an open bay vocational lab. Originally constructed in 1937 (estimated), there has been one major renovations/ addition. The building was completely renovated in 1982 when multiple classrooms, offices and 2 restrooms were added to the west side of the building.

Site: Concrete sidewalks are in good condition and pose no hazard. Landscaped areas include grass and are not irrigated. Site drainage is generally adequate.

Structural/Exterior Closure: The building typically rests on concrete footings and perimeter beams that are not showing signs of settlement or damage. The main structures is typically stucco over metal studs. The roofs are typically flat with modified bitumen and they are leaking. Exterior doors are typically steel and windows are typically aluminum frame, double-pane units.

Interiors: Partition wall types include painted drywall. The interior wall finishes are generally in good condition. Most ceilings are exposed deck and suspended acoustic tile that are in good condition. Flooring in high use areas is vinyl tile and painted concrete. Most other flooring is ceramic tile and carpet. Interior doors are generally solid wood in the corridors and solid wood in the administration and classroom areas.

Mechanical/Plumbing: Heating and cooling is provided by gas fired packaged rooftop units serving the offices and classrooms. The large hanger bays that serve as technical labs are ventilated by motor operated louvers in conjunction with large fans to provide cross ventilation. The noise level of the fans is so loud that the FAA has prohibited their use during instructional periods. A rooftop exhaust fan provides ventilation for the restrooms and is adequate. Domestic hot water is provided from a 20 gallon electric water heater in the Janitor's Room. Plumbing fixtures are in good condition. There are five roof drains that do not have covers and there is no secondary roof drain system.

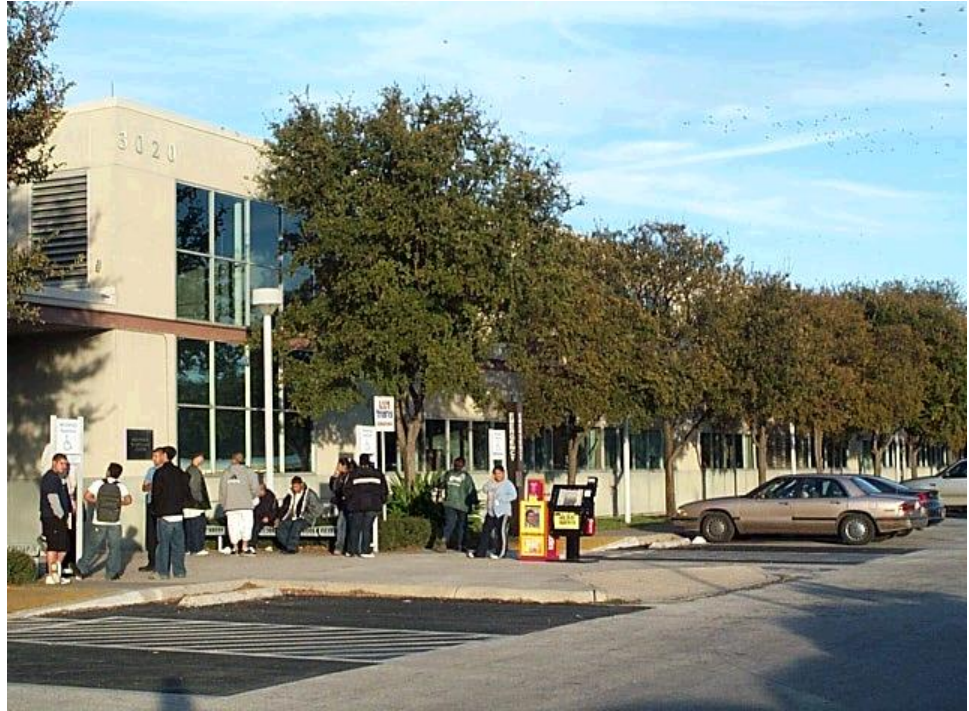
Building 3020 Technology Center

Building 3020 is located on St. Philip's College's Southwest Campus of the Alamo Community College District in San Antonio, Texas. The 1-story, 252,667 square foot building contains offices, classrooms, a library, and vocational work bays. Originally constructed in 1940 (estimate), there has been multiple renovations. A major renovation in 1990 included most interior construction. A limited renovation in 2003 included the interior construction in section C.

Site: Concrete sidewalks are in good condition and pose no hazard. Landscaped areas include trees, grass, and shrubs and are not irrigated. Site drainage is generally adequate.

Structural/Exterior Closure: The building typically rests on concrete footings and perimeter beams that are not showing signs of settlement or damage. The main structure is typically stucco over metal studs. The roofs are typically flat and they are leaking. Exterior doors are typically aluminum and windows are typically aluminum frame, single-pane units.

Interiors: Partition wall types include painted CMU, drywall. The interior wall finishes are generally in fair condition. Most ceilings are exposed deck and 2x4 suspended acoustical tile that are in poor condition. Flooring in high use areas is vinyl tile and painted concrete. Most other flooring is vinyl tile and carpet. Interior doors are generally hollow metal in the corridors and solid wood in the administration and classroom areas.

Mechanical/Plumbing: Gas-fired packaged rooftop units provide heating and cooling for this complex. The energy management system has removed local environmental control for the Library (C123). This has created an issue with humidity control and organic growth on educational materials and periodicals. Also, this room is experiencing serious issues with cooling. A study should be conducted to ascertain a feasible solution for these problems. All of the high bay technical labs reach 120-130 degree temperatures in the summer. These rooms become too hot for the educational environment. The existing ventilation systems are inadequate under these extreme conditions. A study should be conducted to find a viable solution to mitigate this problem. Heating in the high bay technical labs is adequate. Roof exhaust fans provide ventilation for restrooms and ventilation is inadequate in some areas. Temperature controls were upgraded in 2004 and are operated through an energy management system. It appears that there are very few restrooms in relationship to the student/faculty population. The restroom facilities should be evaluated for their adequacy for the current student/staff population. Plumbing fixtures are generally in good condition, with a few exceptions.

Electrical: The electrical system is fed from a 1500 kVA pad mounted transformer that delivers 277/480 volt, 3-phase, 4-wire power to the facility. The service to the building is rated at 5000 amps. Lighting is typically fluorescent. Lighting levels throughout the facility are generally inadequate. An example is in the Library (C123) reading area where illumination is approximately 35 foot candles. Illumination at the stacks was recorded at 20 foot candles. Most educational areas have lighting levels well below ACCD standards. A study should be conducted to determine a viable solution for this issue. The electrical bus duct is original to the building. It is pitted and continues to deteriorate. Due to its age, bus switches/disconnects have to be special ordered and fabricated. It is recommended that the bus duct be replaced. Emergency lights are either hard-wired wall units or ceiling mounted fluorescent lights with battery backup. Emergency exit signs are present and are typically illuminated. The building does not have an emergency generator. There is a 1500 kVA transformer in Room A100 that is making excessive noise. It is recommended that this transformer be serviced and possibly tested by a certified electrician. Classroom A109 needs 480 volt power for classroom demonstration purposes.

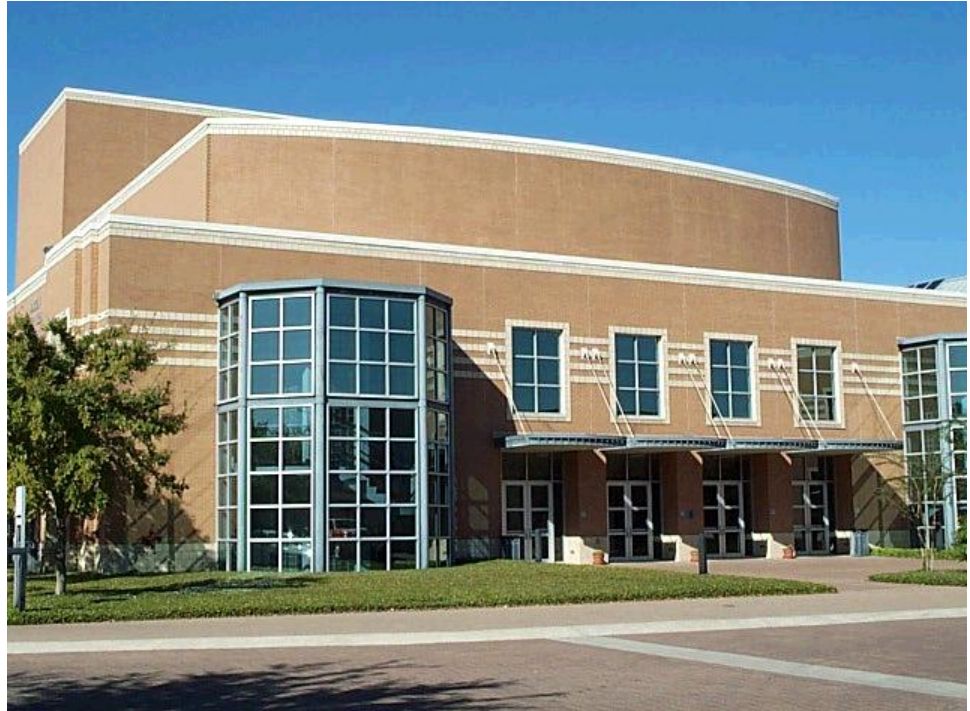
The Watson Theatre and Fine Arts Building is located on the St. Philip's College Campus of the Alamo Community College District in San Antonio, Texas. The 2 story, 50,360 square foot building contains offices, classrooms, a theatre and art studios. Originally constructed in 1993, there have been no renovations or additions.

Electrical: The service to the building is rated at 1600 amps. Lighting is typically fluorescent, except in the stage area. Dimming equipment was replaced in 2003. There is a 125 kVA emergency generator providing 277/480 volt power to this building. This generator provides emergency power for lights and fire pump control. The emergency generator is in good condition.

Fire Protection/Life Safety Systems: The fire alarm system consists of audio/visual annunciators in the corridors. Pull stations and smoke detectors activate the system. This system is centrally monitored. The fire alarm system is original to the building and is beyond its expected useful life. This system should be considered for an upgrade at the next major renovation. Lighted exit signs are present and adequate. This building does not have a security system. A fire sprinkler system is present in this building.

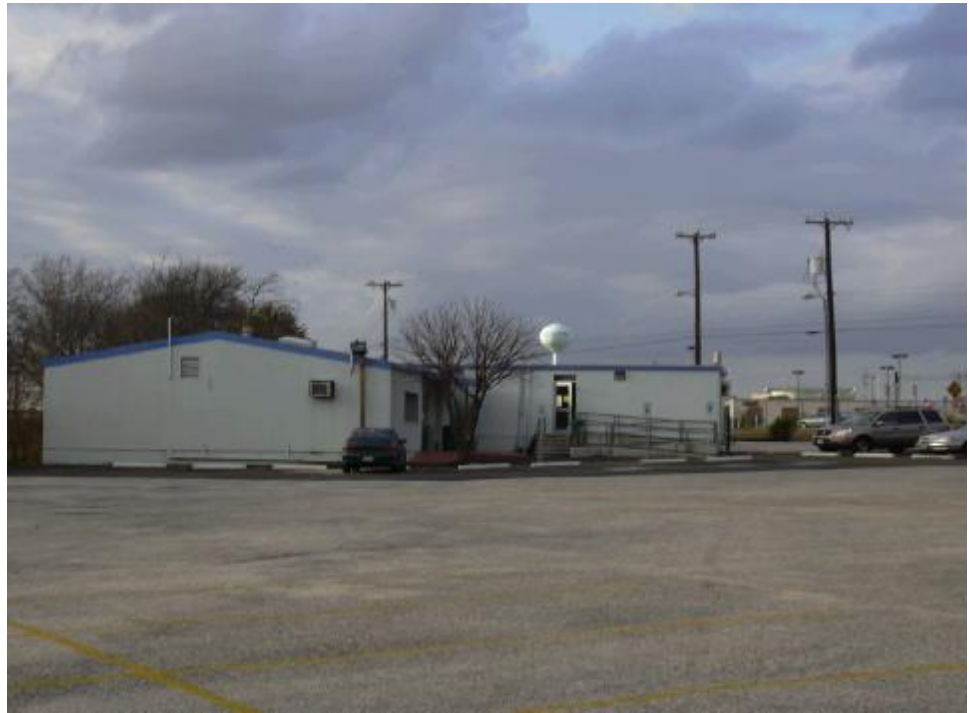
Northeast Campus, Building 7980.

Building 7980 is located on the Northeast Campus of the Alamo Community College District in Universal City, Texas. The 1-story, 4,297 square foot building contains offices and classrooms. Originally constructed in XXX, the most recent renovation was in 2001.

Site: Concrete sidewalks are in fair condition and pose no hazard. Landscaped areas include trees and grass which are not irrigated. Site drainage is generally adequate.

Structural/Exterior Closure: The building rests on footings and foundation walls that are not showing signs of settlement or damage. The main structure is metal framed with EFIS exterior walls. The roof is standing seam metal and it has minor leaks. Exterior doors are typically single-pane aluminum units. Windows are typically aluminum, single-pane units.

Interiors: Partition walls are typically painted drywall. The interior wall finishes are generally in fair condition. Ceilings are lay-in-tile in fair condition. Flooring in all areas is carpet. Interior doors are generally flush solid wood.

Mechanical/Plumbing: The heating and cooling in this building is provided by four split system DX systems and two BARD wall units. It appears that these units were installed in 2000. Ceiling exhaust fans provide exhaust for the restrooms. It could not be determined if these units are ducted to the attic or to the roof. Plumbing fixtures are in good condition.

Fire Protection/Life Safety Systems: The fire alarm system consists of audio/visual annunciators in classrooms, corridors, and restrooms. The system is activated by pull stations and/or smoke detectors. This fire alarm system was installed in 2000 and is in good condition. There is no fire sprinkler system in this building. There is no security system for this building.

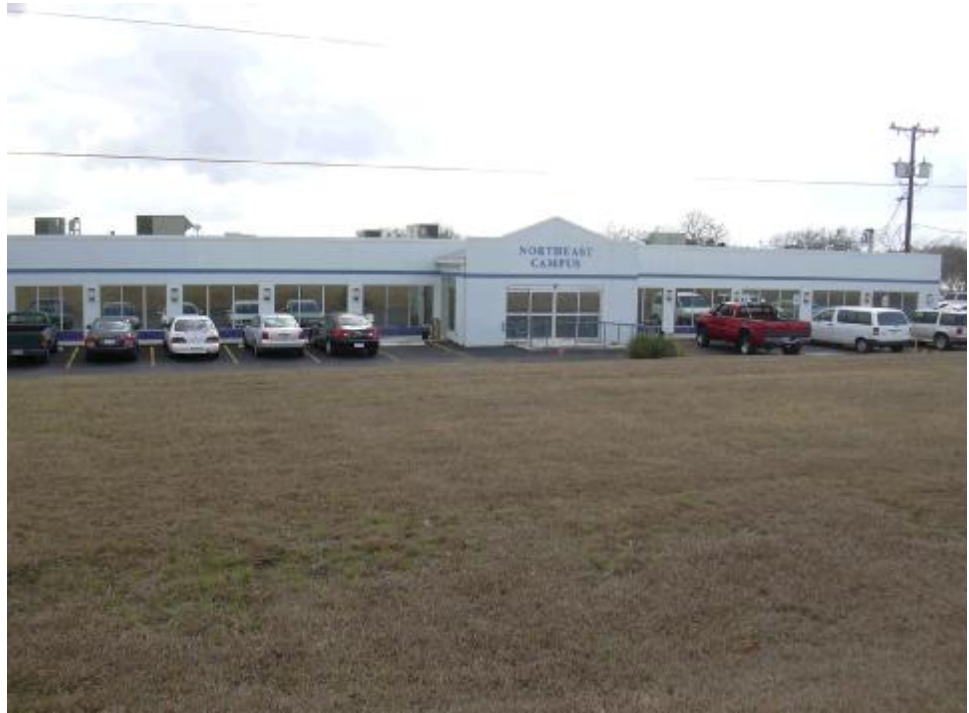
Northeast Campus, Building 7990.

Building 7990 is located on the Northeast Campus of the Alamo Community College District in Universal City, Texas. The 1-story, 17,250 square foot building contains offices and classrooms. Originally constructed in XXX, the most recent renovation was in 2001.

Site: Concrete sidewalks are in fair condition and pose no hazard. Landscaped areas include trees and grass which are not irrigated. Site drainage is generally adequate. Part of the parking lot has been resurfaced and restriped recently; the remainder needs resurfacing as well.

Structural/Exterior Closure: The building rests on footings and foundation walls that are not showing signs of settlement or damage. The main structure is metal framed with pre-cast concrete panels. The roof is a built-up system and it is leaking. Exterior doors are typically single-pane aluminum units. Windows are typically aluminum, single-pane units.

Interiors: Partition walls are typically painted drywall. The interior wall finishes are generally in fair condition. Ceilings are lay-in-tile that is in fair condition. Flooring in high use areas is carpet. Most other flooring is carpet. Interior doors are generally flush solid wood.

Mechanical/Plumbing: Heating and cooling is supplied by seven packaged rooftop units and one split system DX unit. Five 10-ton rooftop units and the split system DX unit were installed during the 2001 renovation. The two 2-1/2 ton rooftop units were manufactured in 2003. A roof exhaust fan serves the public restrooms. This roof exhauster was not running at the time of this survey. A ceiling exhaust fan serves the faculty restroom and ventilation is adequate. These exhaust fans were installed in the 2001 renovation. Overall, the heating and cooling system appears to be in good condition. Plumbing fixtures were installed during the 2001 renovation and are in good condition.

Fire Protection/Life Safety Systems: The fire alarm system consists of audio/visual annunciators in classrooms, corridors, and restrooms.

The system is activated by pull stations and/or smoke detectors. The system is centrally monitored. The building has a fire sprinkler system. This facility has a security system utilizing security cameras which are monitored in the security office.

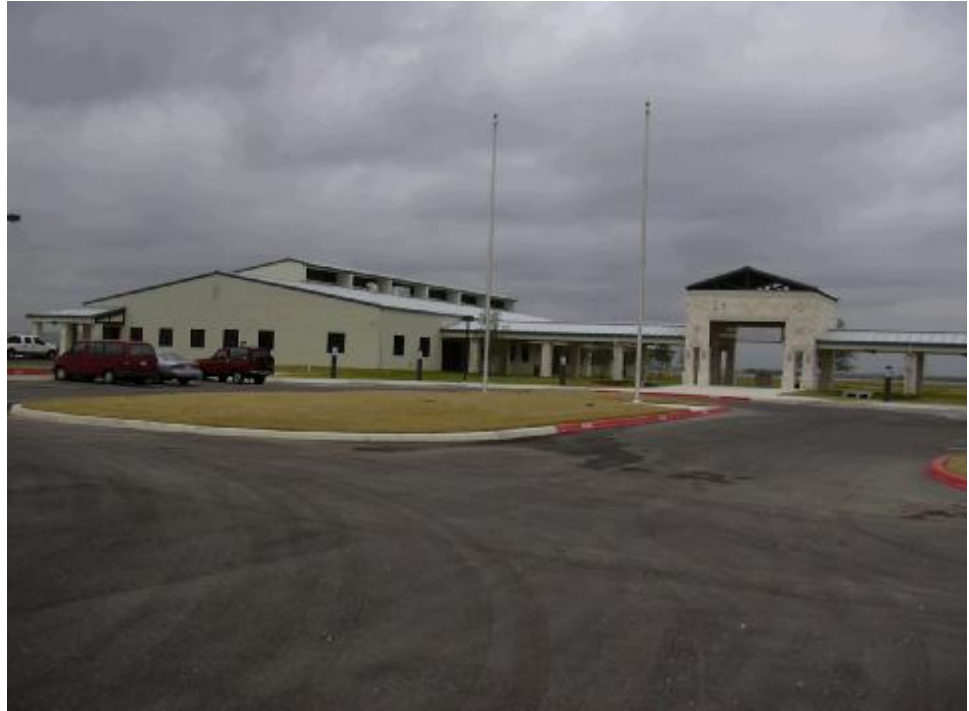
Central Texas Technology Center.

The Central Texas Technology Center is located on Farm Road 758 near the municipal airport in New Braunfels, Texas. The 1-story, 24,786 square foot building contains offices, classrooms, and vocational labs. Originally constructed in 2004, there have been no renovations.

Site: Concrete sidewalks are in good condition and pose no hazard. Landscaped areas include trees and grass which are not irrigated. Site drainage is generally inadequate, however the New Braunfels City Engineer is currently addressing the problem.

Structural/Exterior Closure: The building rests on a concrete slab on grade. The main structure is metal framed with either metal or stucco exterior walls. The roof is standing seam metal and it is not leaking. Exterior entrances are typically aluminum storefronts with single-pane doors and double-pane side lites. Windows are typically double pane aluminum units.

Interiors: Partition walls are typically painted drywall on metal studs. The interior wall finishes are generally in good condition. Ceilings are either lay-in-tile or exposed deck that is in good condition. Flooring in high use areas is VCT. Most other flooring is VCT in classrooms or carpet in offices. Interior doors in offices and classrooms are generally flush solid wood or metal in the vocational lab area.

Electrical: The electrical system is fed from a 500 KVA, pad mounted transformer that delivers 277/480 volt, 3-phase, 4-wire power to the building. The service is rated a 2000 amps. The main distribution panel is furnished with a transient voltage surge suppressor (TVSS). There is a 225 KVA transformer in the Auto Shop and a 75 KVA transformer in the Mechanical Room. These transformers provide 208/120 volt, 3-phase power to the complex. Light fixtures are typically parabolic fixtures with T-8 fluorescent bulbs. The lighting system is on a time clock. Emergency lights are hard wired wall pack units with battery backup. Emergency lights are present. Emergency exit signs are present and are typically illuminated. There is no emergency generator for this building.

Fire Protection/Life Safety Systems: The fire alarm system consists of visual/audio annunciators in offices, corridors and restrooms. The system is activated by pull stations and/or smoke detectors, and is centrally monitored. The complex has a fire sprinkler system. The security system is comprised of security cameras at entrances, hallways, technical labs, and parking lots.

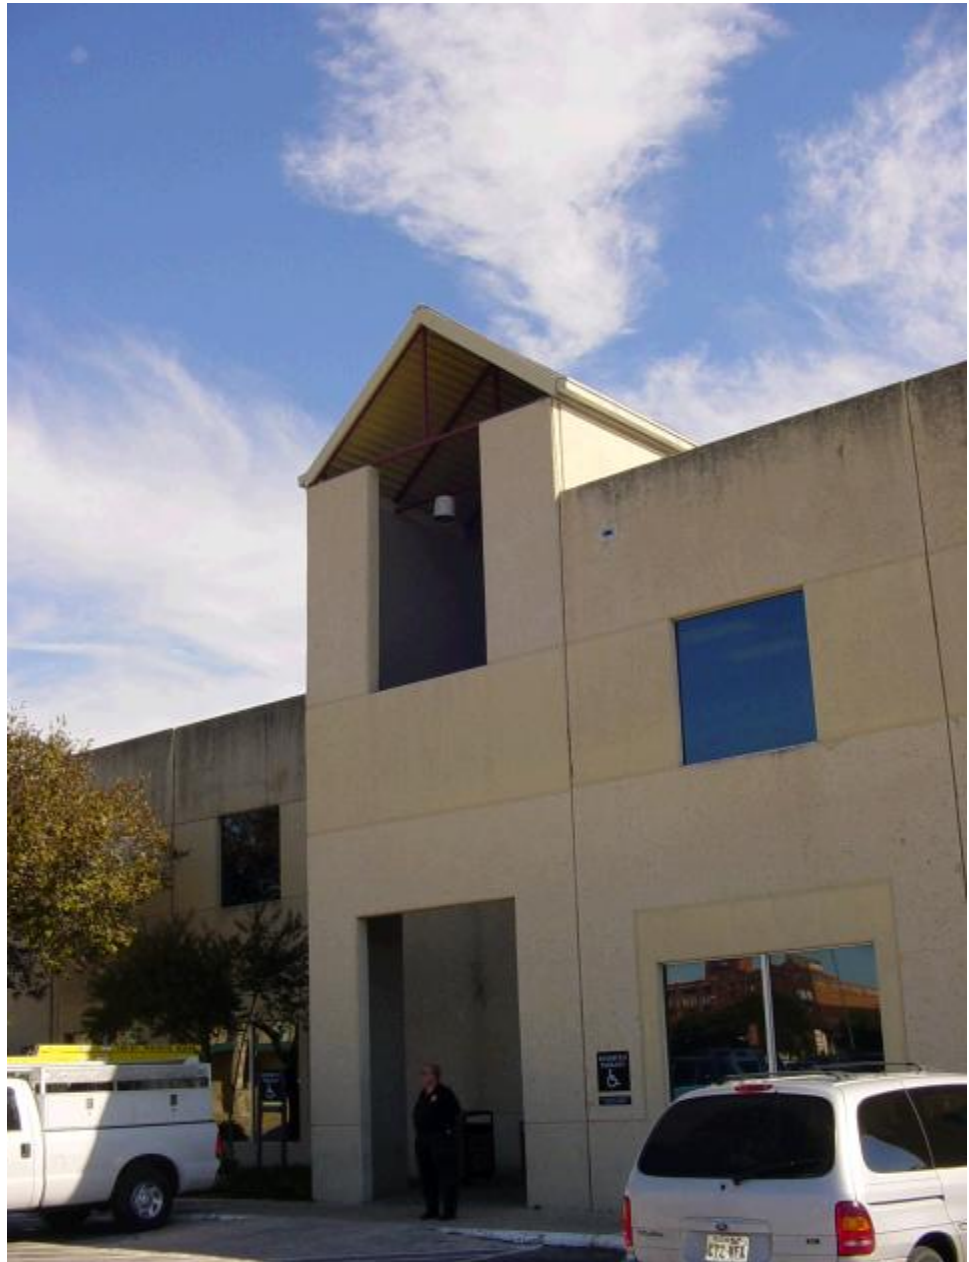
Photo Description:District Administration Building at
811 W. Houston

The Alamo Community College Administration Building is located at 811 West Houston Street in San Antonio, Texas. The 2-story, 30,280 square foot building contains offices, conference rooms, and a computer center. The main building, constructed in 1983, was an addition to a small two story building which existed on the site since 1910.

Site: Concrete sidewalks are in good condition and pose no hazard. Landscaped areas include trees, grass, and shrubs and are irrigated. Site drainage is generally adequate.

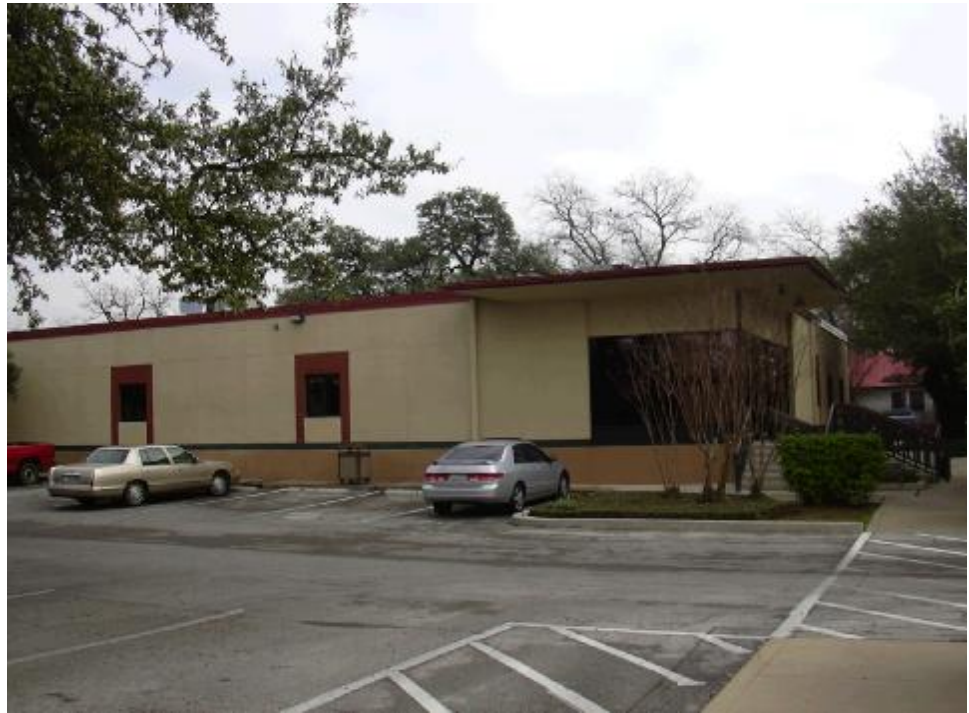
District Administration - Building A

Administration Building A is located on the Sheridan Street Campus of the Alamo Community College District in San Antonio, Texas. The 1-story, 10,059 square foot building contains offices. Originally constructed in 1960, there has been several renovations. The building was originally renovated when it was purchased by ACCD. This was reportedly a complete renovation which took place in 1995, and included all interiors, mechanical systems, and roofing. There appears to have been a more recent partial renovation in 2002 (estimate) limited to reconfiguring the acquisitions and overcrowded Human Resources offices.

Site: Concrete sidewalks are in fair condition and pose no hazard. Landscaped areas include trees, grass, and shrubs and are irrigated. Site drainage is generally adequate.

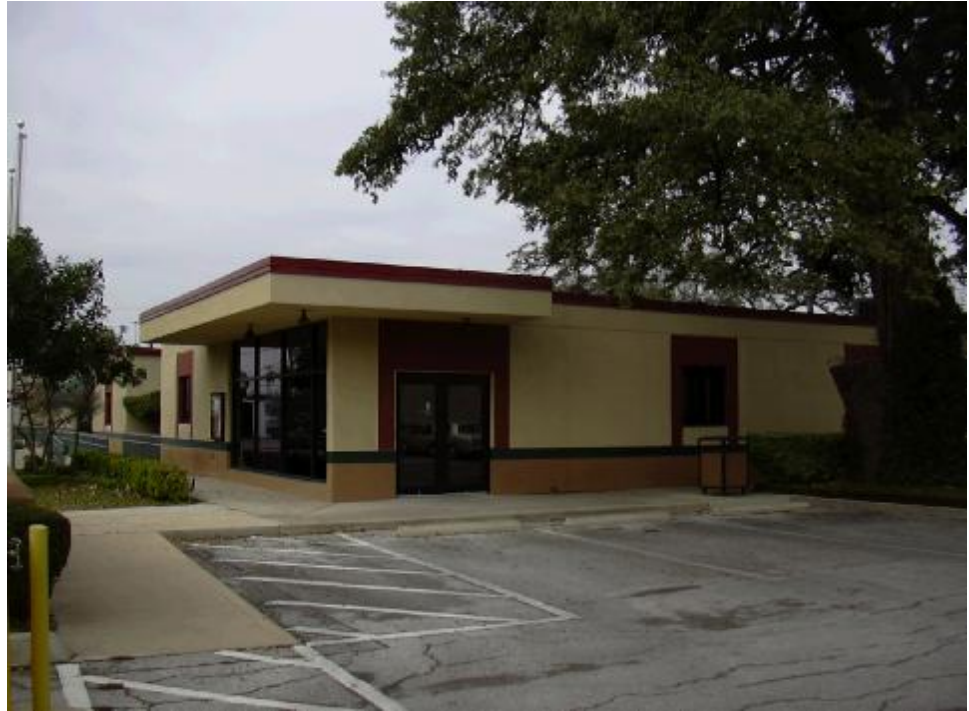
District Administration - Building B

Administration Building B is located on the Sheridan Street Campus of the Alamo Community College District in San Antonio, Texas. The 1-story, 3,362 square foot building contains offices. Originally constructed in 1960, there has been several renovations. The building was originally renovated when it was purchased by ACCD. This was reportedly a complete renovation which took place in 1995, and included all interiors, mechanical systems, and roofing. There appears to have been a more recent partial renovation in 2002 (estimate) limited to reconfiguring the Chancellor's Office.

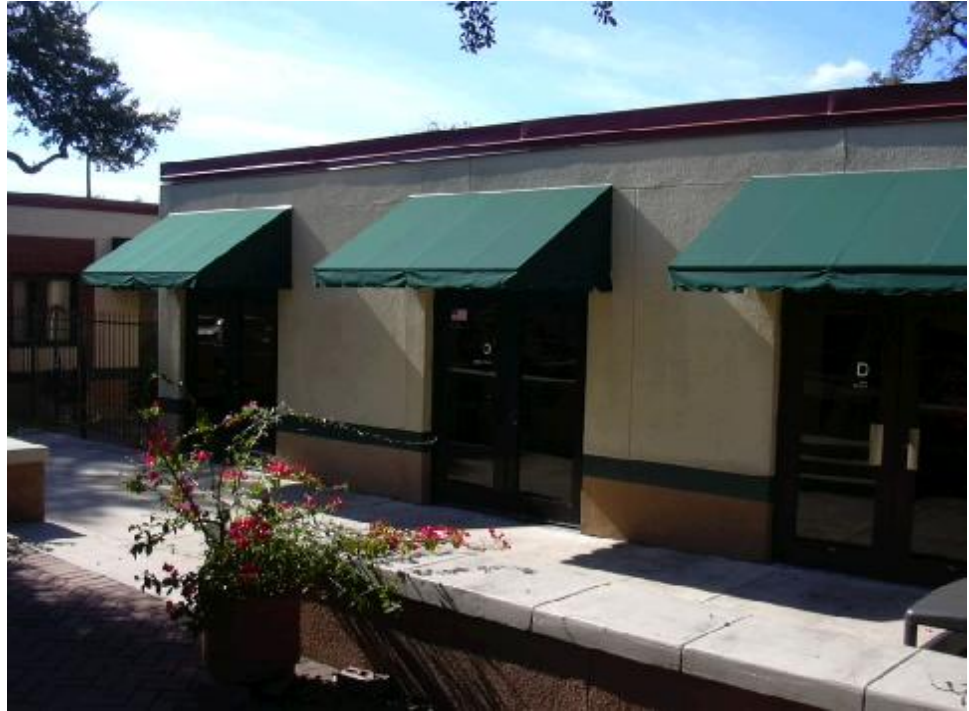
Photo Description:District Administration - Building
C/D/E

Administration Building C/D/E is located on the Sheridan Street Campus of the Alamo Community College District in San Antonio, Texas. The 1-story, 30,471 square foot building contains offices, conference rooms, and the district law enforcement headquarters. Originally constructed in 1960, there have been several renovations. The building was originally renovated when it was purchased by ACCD. This was reportedly a complete renovation which took place in 1995, and included all interiors, mechanical systems, and roofing. There appears to have been a more recent renovation in 2002 (estimate) to Section E and included all interiors.
